Project No. T237-12

TAS 100-95
TEST PROCEDURE FOR WIND AND WIND DRIVEN RAIN
RESISTANCE OF DISCONTINUOUS ROOF SYSTEMS
PERFORMANCE TEST REPORT

150 ULTIMATE PIPE FLASHING

LIFETIME TOOL & BUILDING PRODUCTS LLC
250 AIRPORT ROAD
WINCHESTER, VA 22602

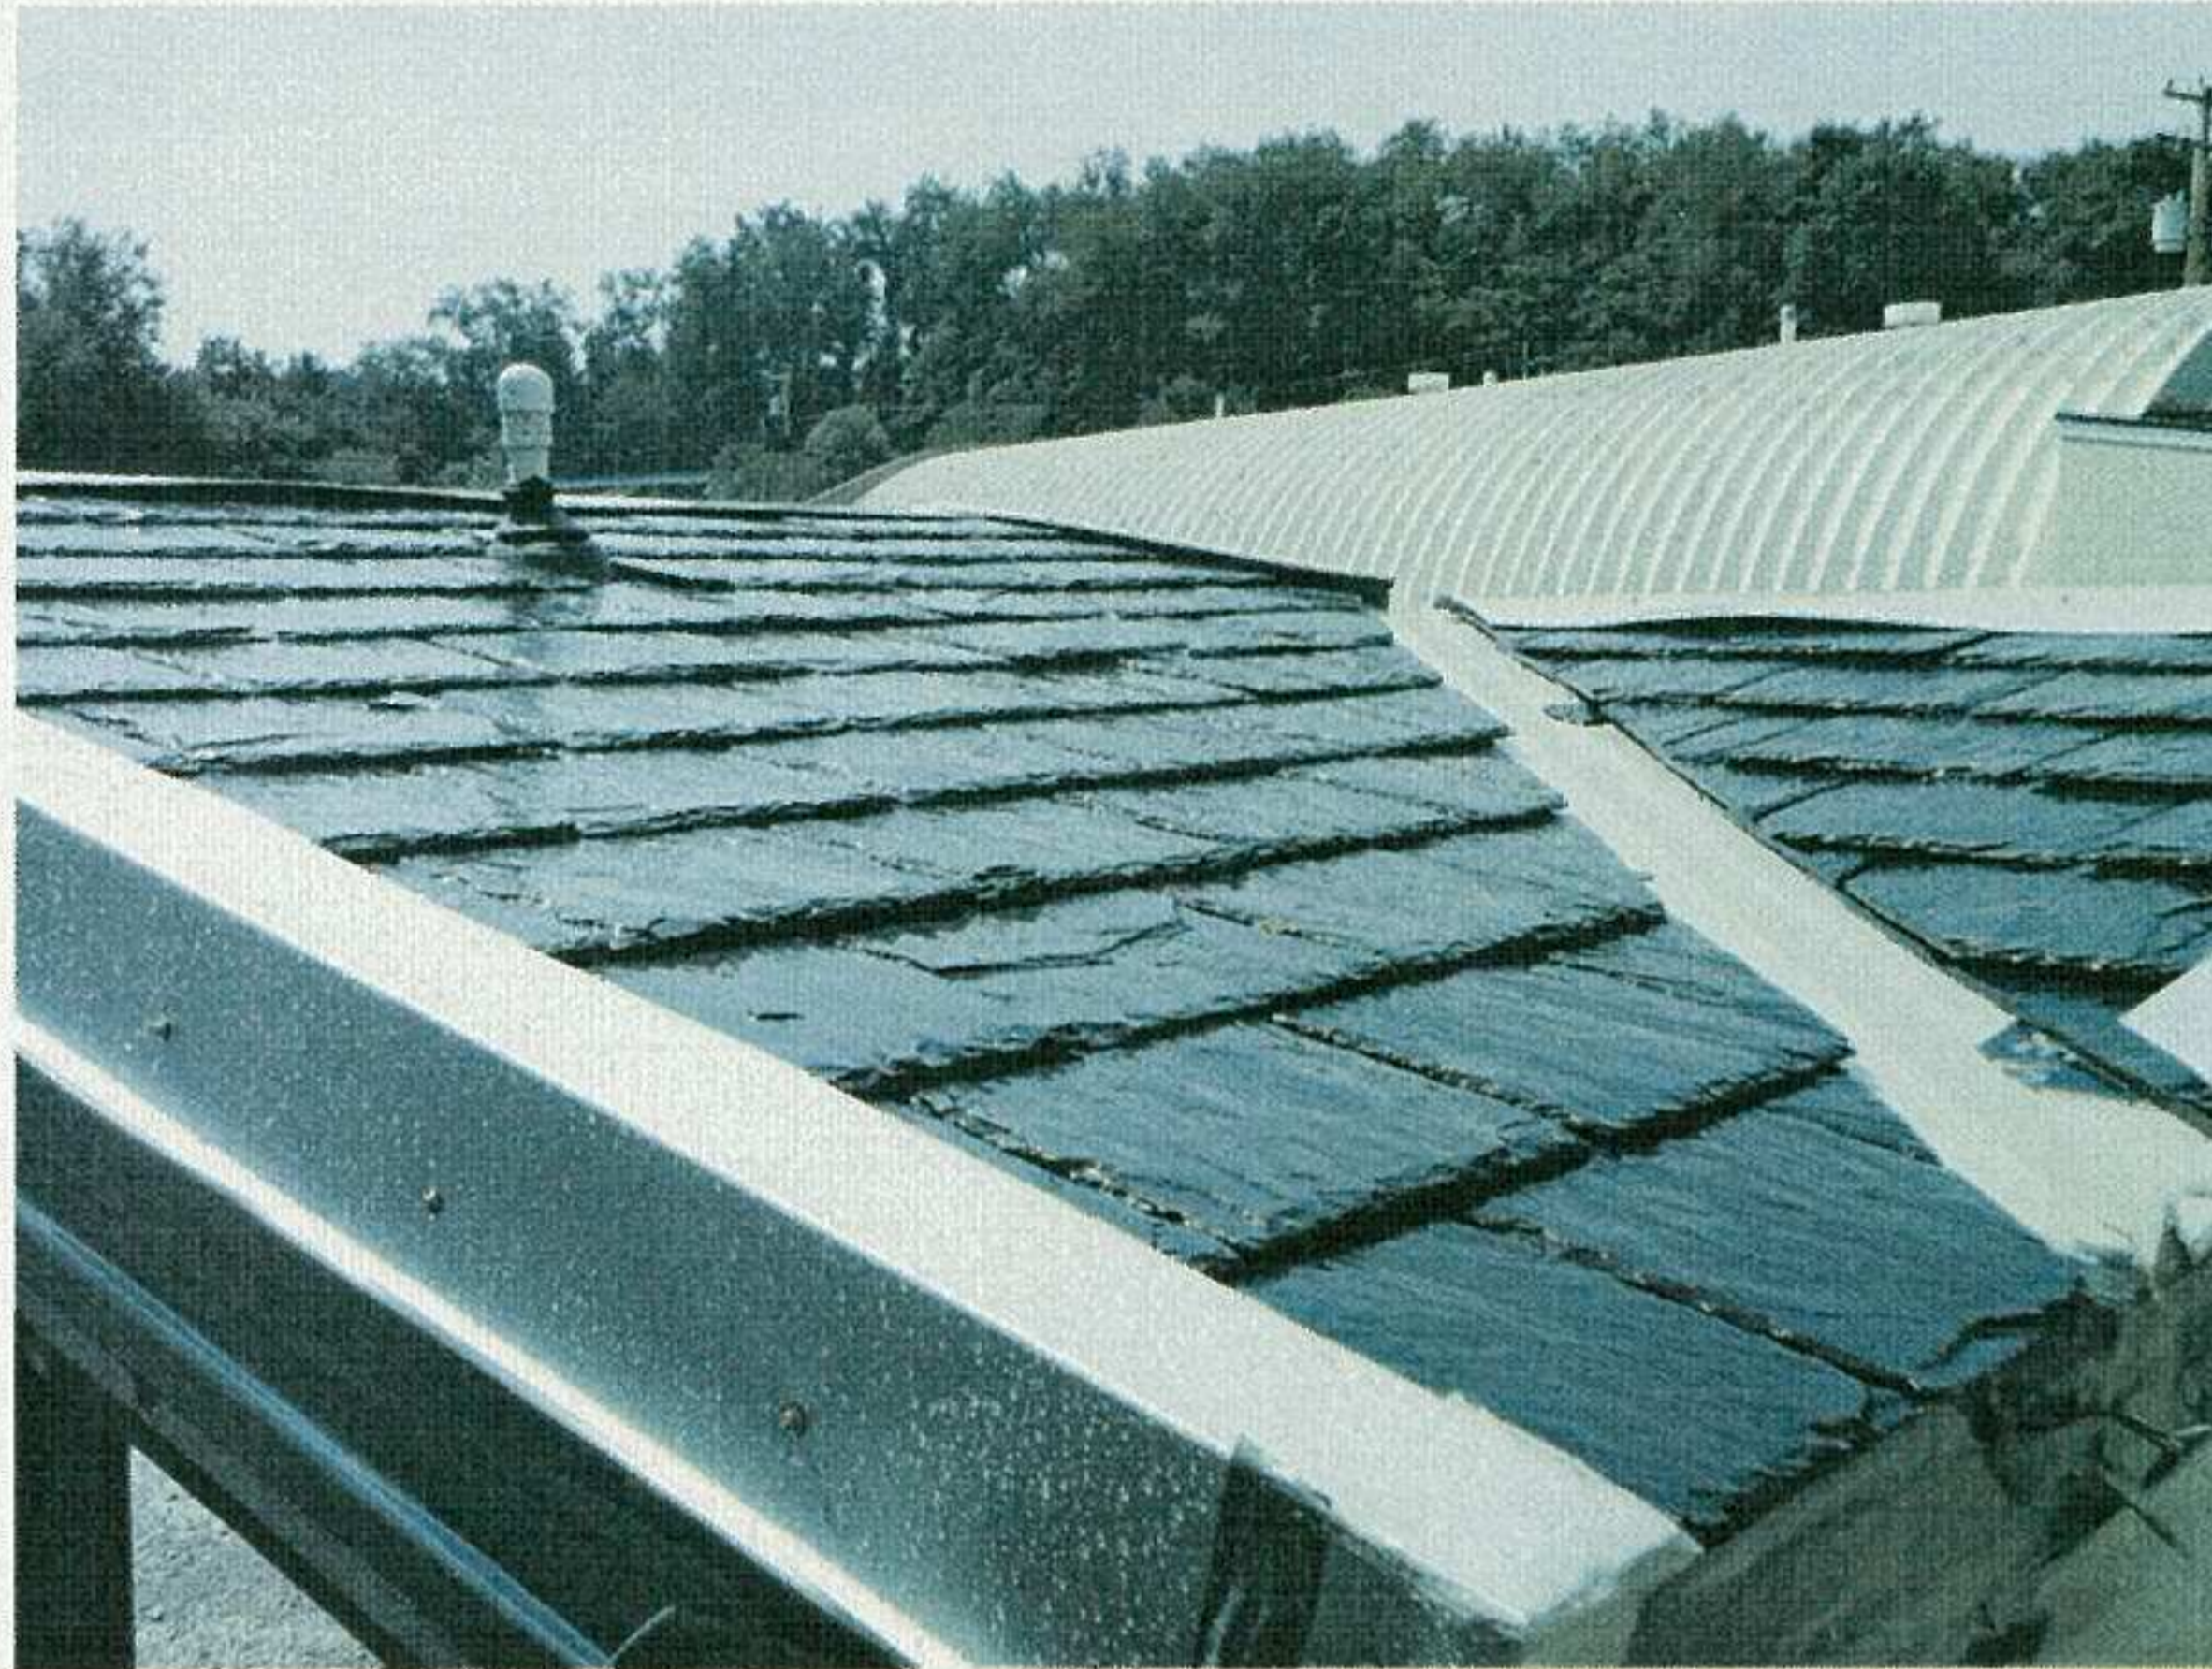
TOPSIDE OF ASSEMBLY AFTER TESTING

Upon completion of the test intervals, visual observation indicated that there was no damage to the roof system and no water infiltration on the underside of the sheathing.

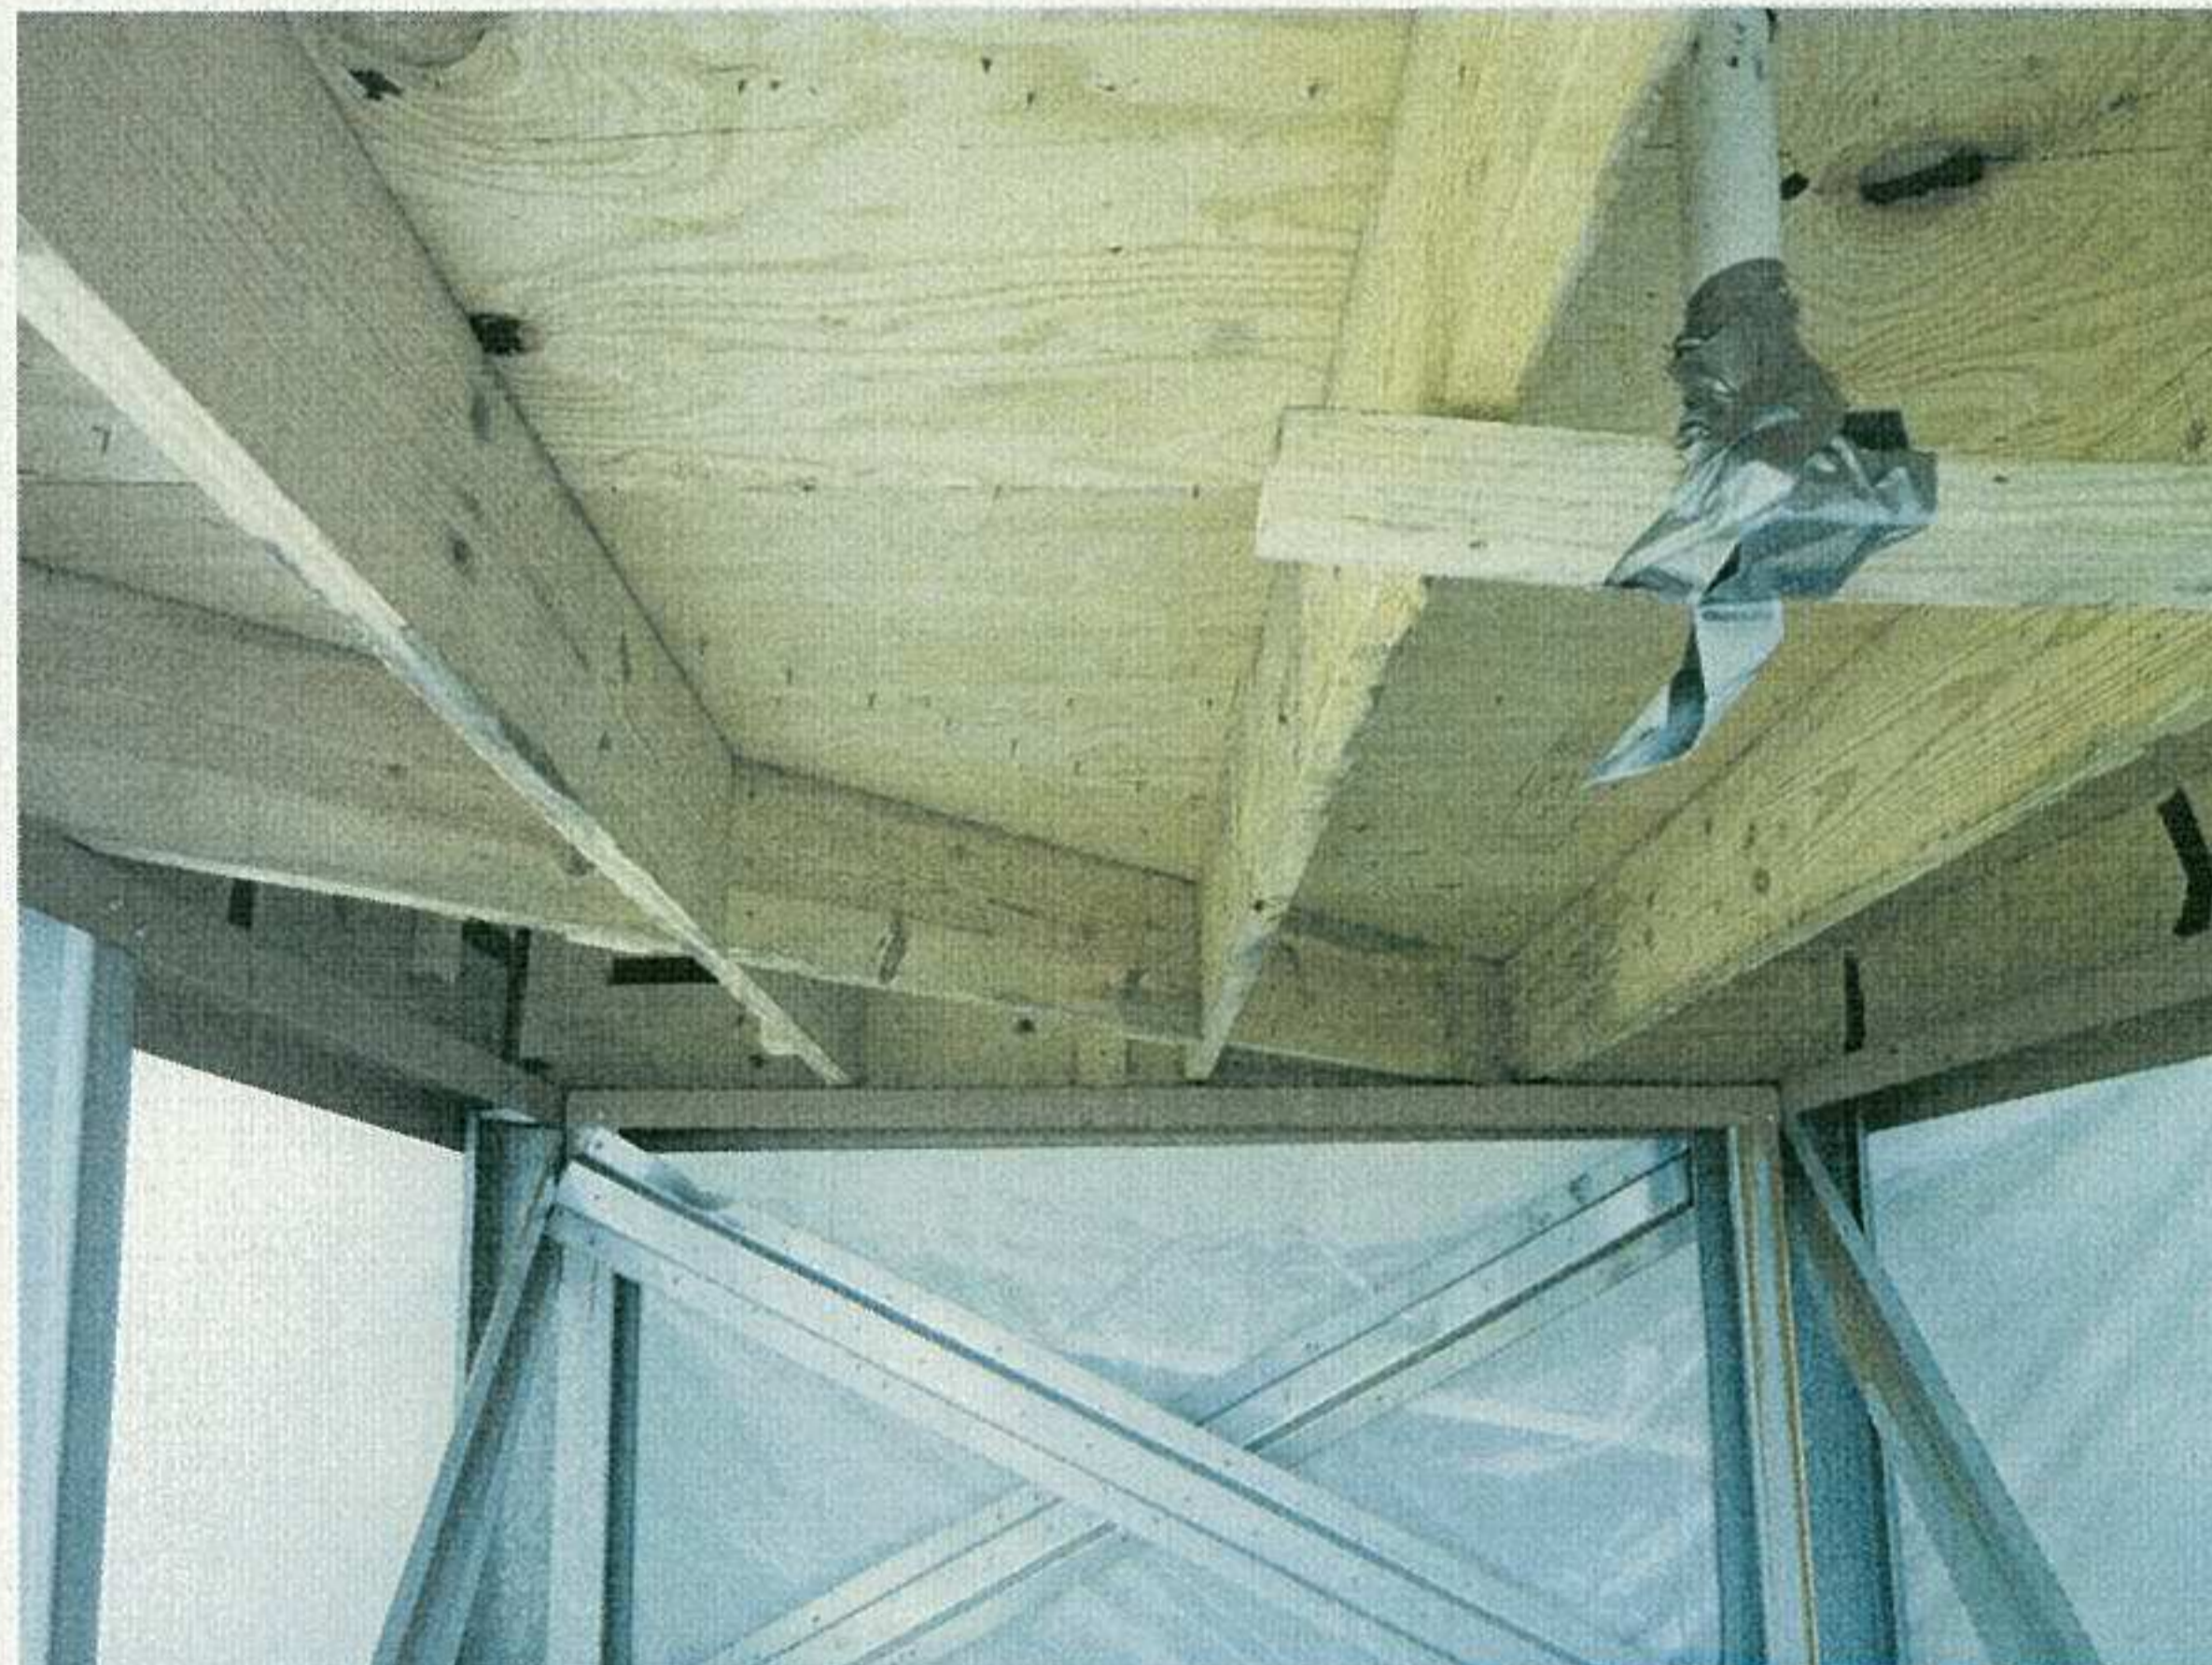
UNDERSIDE OF ASSEMBLY AFTER TESTING
